TEST REPORT

Report No.: THSH20123028663EN

Sample Description : Transmitter instrument housing

Test Requested : IP65

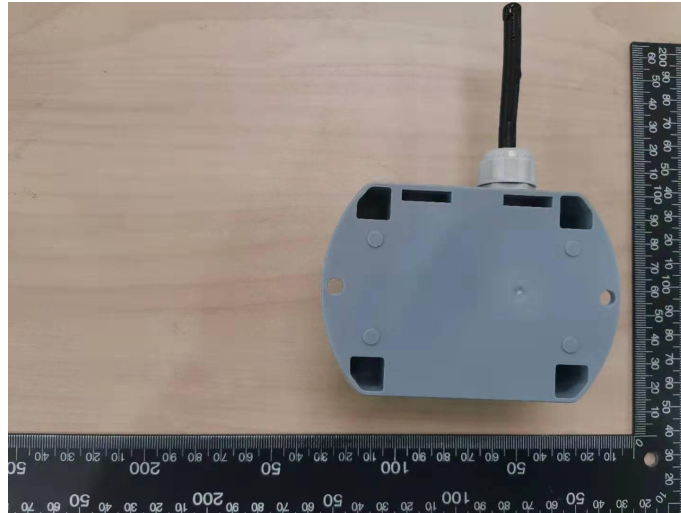
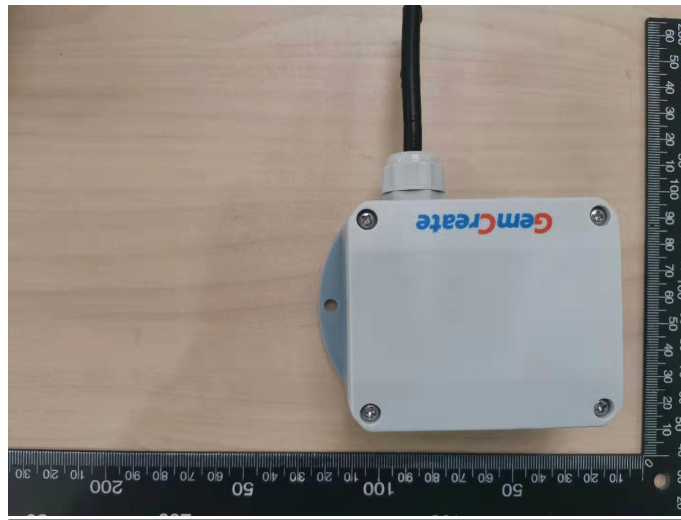
SAMPLE PHOTO

Sample Material : PC plastic

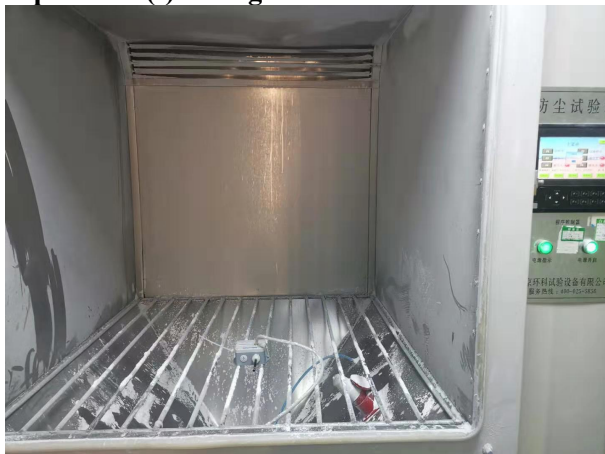
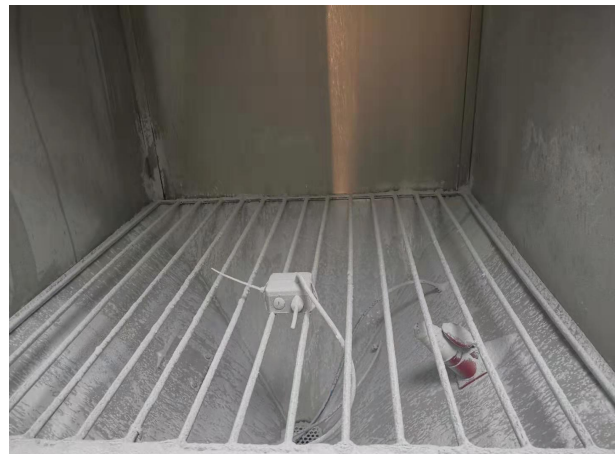
Sample Photo(s) during the test:

1. Test Item: IP6X Dust proof

Test Setup: Dust Laboratory , model : SC-010

Test Conditions: The amount of talcum powder:2Kg/m3; Test time:8H; The depression shall not exceed 2kPa(20mbar).

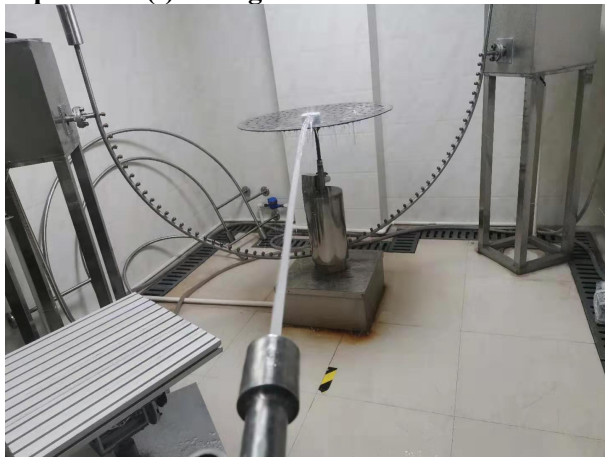
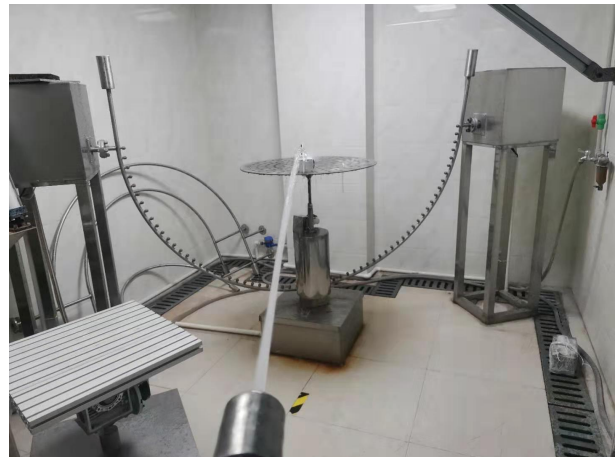
Sample Photo(s) during the test:

2. Test Item: IPX5 Water proof

Test Setup: Open type of water teste quipment, Model : IPX1-8

Test Conditions: internal diameter of the nozzle:6,3mm;delivery rate:12,5l/min \pm 5%;test duration per square metre of enclosure surface area likely to be sprayed:1 min;minimum test duration:3min;distance from nozzle to enclosure surface:between2,5m and3m.

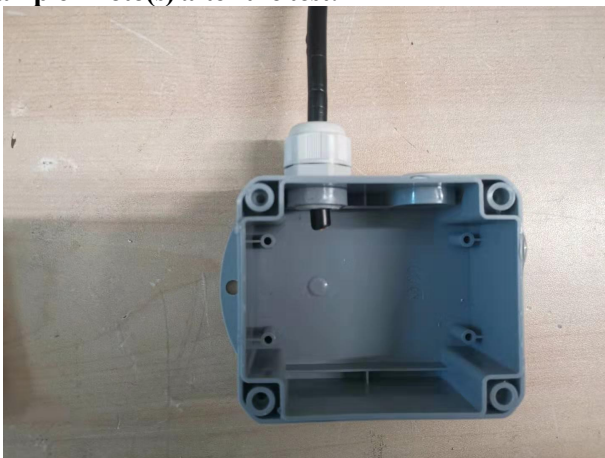
Sample Photo(s) after the test:

Sample Name	Test Results
Transmitter instrument housing	After the dust test, on inspection, the internal of the sample without water.
